Submission to: Dr Mark Lonsdale
Independent Chair
Independent Technical Reference Group
Re: Wild Horse Damage around Currango Homestead
Made by: Friends of Currango Inc. (FoC)
Date: 13 April 2015

Background – Currango.

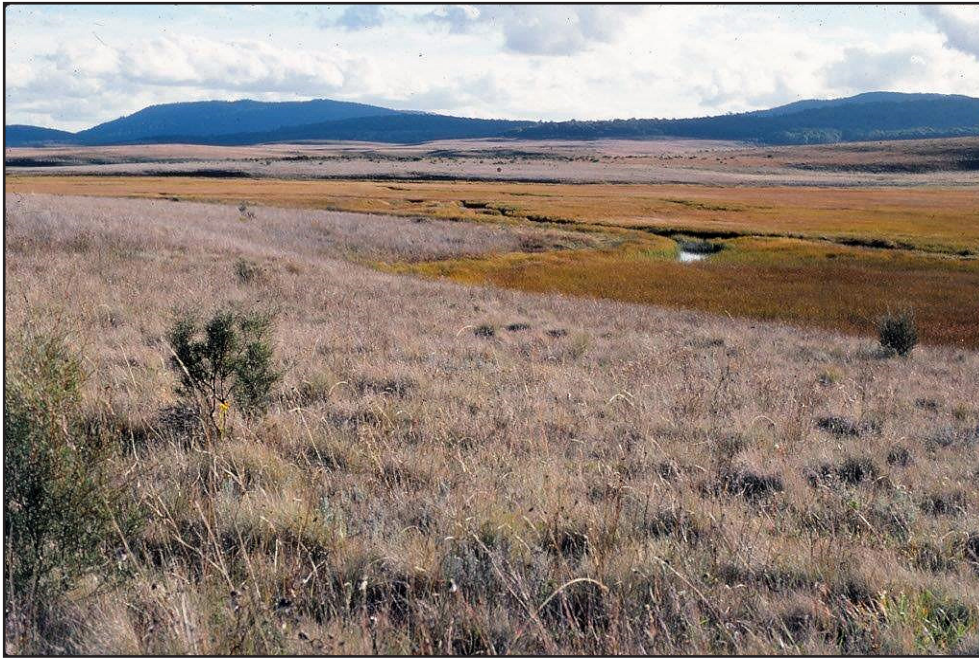
The prevailing condition of the swamps 20 to 30 years ago is clearly shown in attached photographs numbers 1 to 3. In photo 2, the height of the grass is clearly evident in relation to the remnant fence line. The fence line is also evident in photo 3, but harder to detect as it is further away.

Whereas the stream and adjoining swamp, as shown in photos 1 to 3, were permanent features of the landscape as recently as approximately ten years ago, these features have now completely disappeared.

Photos of the swamp from about thirty years ago. The fence line in Photos 2 and 3 gives an idea of the height of the vegetation, the base of which sat in about a foot of water. The foreground of Photos 2 and 3 demonstrates the presence of a clean, significant, well-defined stream

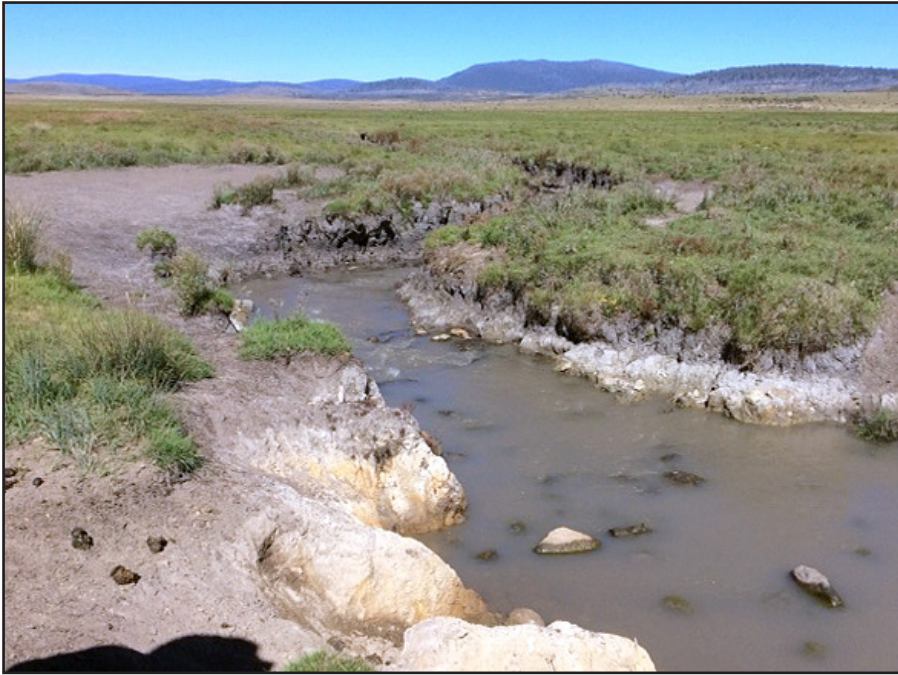
At this point there was an overwhelming change in the creek, its bed and surrounds. Whereas, downstream the creek banks, although damaged, are still well defined, from here on upstream, the banks are significantly trodden down. This is evident in attached photos 4 to 8.

Instead of a well-defined creek (as in photos 2 and 3) flowing through banks pocked with holes left by platypus and yabbies, the water, now a milky grey colour, sits in a wide and shallow cavity. There is no longer any obvious vegetation either nearby or in the water, and much of the creek bed has been hollowed out, and is now showing the bedrock

***Walking north along
Currango Creek, from
about 1km above the
Causeway***

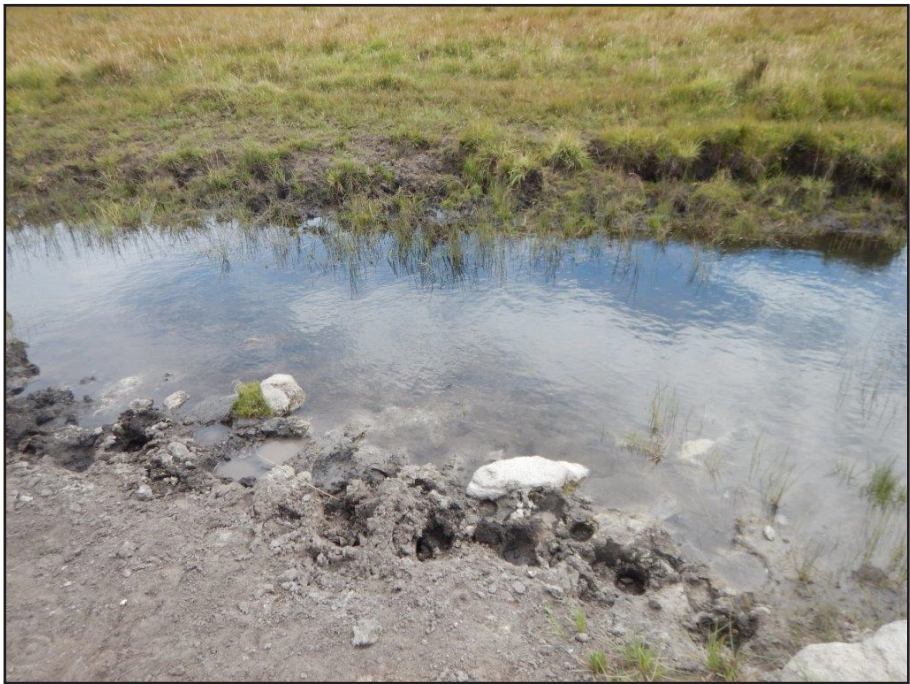
In late March, another four of our members conducted a further investigation. They entered the creek where it is tiny, at the bridge on Pockets Saddle Road, and then walked downstream. They found similar conditions to those referred to above. The banks of the creek have been destroyed and there is no wetland where previously water was 20cm deep across the swamp. See photos 10 to 14.

***Walking south from
the Confluence of
Currango Creek
and Gurrangorambla
Creek***

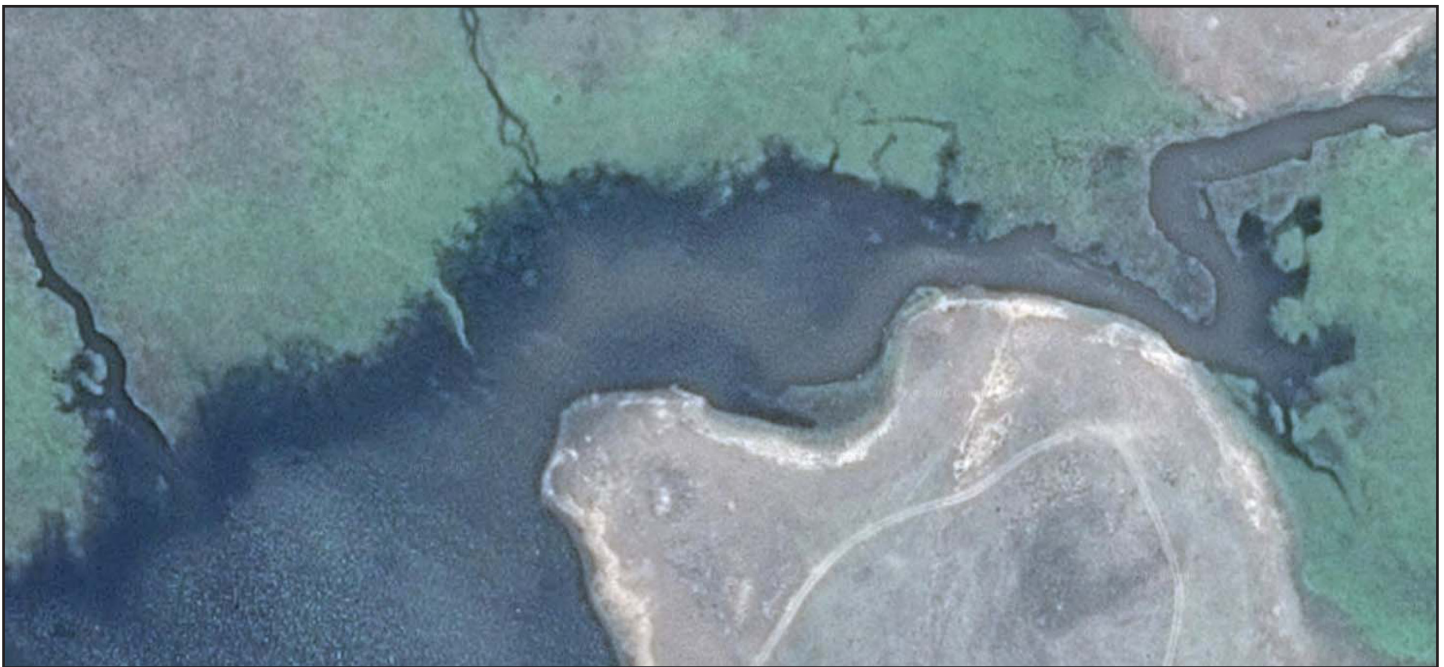
12

We found that the water in the lower reaches appeared to be clear enough. However, an aerial photo (GoogleEarth) that we now supply shows the entry of water from Currango Creek into Tantangara, and it can be seen that the inflowing water is discoloured. This was not previously the case. A rising Tantangara Reservoir usually inundates this lower part of the creek above and below the Port Phillip Fire Track causeway for a few weeks each year.

Aerial View of Gurrangorambla / Currango Creek Entry to Tantangara
(from GoogleEarth, 29/1/14)
